**Flood Control Project Maintenance
Levee Inspections**

Fall 2011 Levee Maintenance Deficiency Summary Report

Reclamation District No. 0003 Grand Island

Levee Inspection Report By Mile - Fall 2011

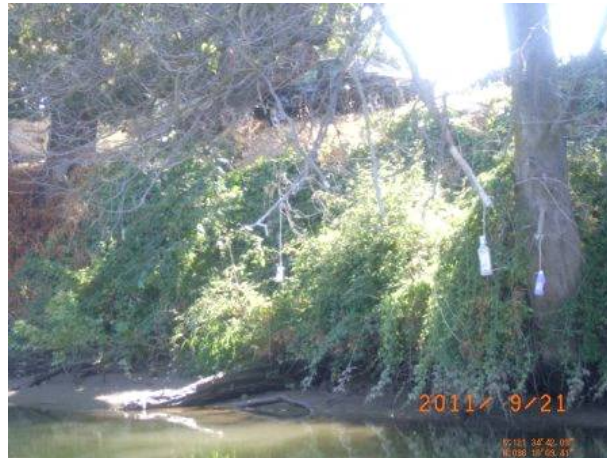
USACE 2011 Photo #1

Levee Mile Report Line	1
Start Levee Mile	0.12
End Levee Mile	0.23
Location	Water Side
Category	Supplemental
Item	USACE Erosion Survey

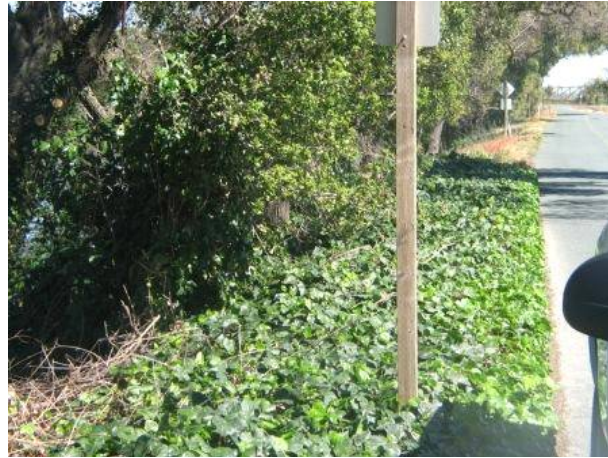
Levee Mile Report Line	2
Start Levee Mile	0.22
End Levee Mile	0.33
Location	Water Side
Category	Earthen Levee
Item	Encroachments

Looking upstream at dense landscaping on waterside slope from LM 0.22 to 0.28

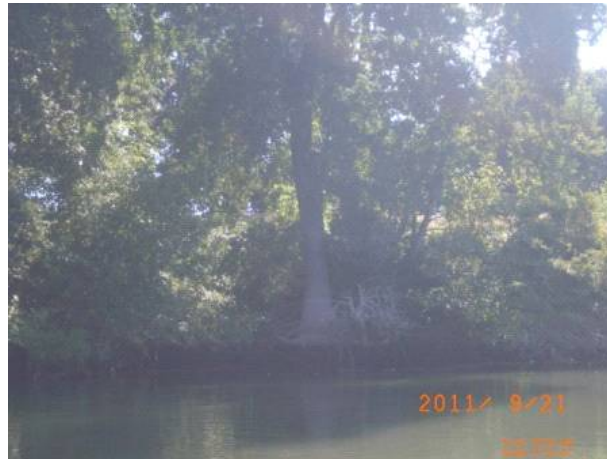
USACE 2011 Photo #1

Levee Mile Report Line	6
Start Levee Mile	0.94
End Levee Mile	1.14
Location	Water Side
Category	Supplemental
Item	USACE Erosion Survey

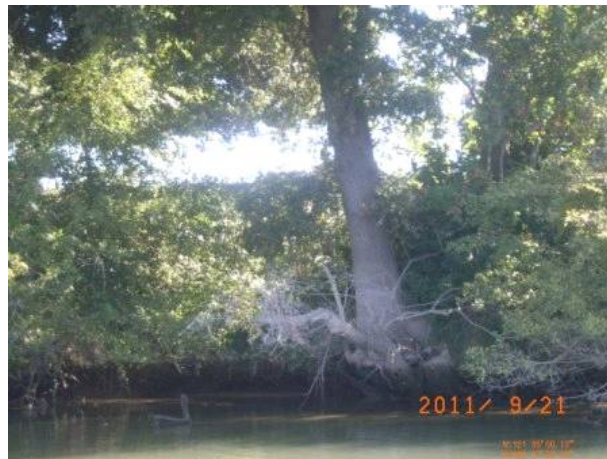
USACE 2011 Photo #2

Levee Mile Report Line	6
Start Levee Mile	0.94
End Levee Mile	1.14
Location	Water Side
Category	Supplemental
Item	USACE Erosion Survey

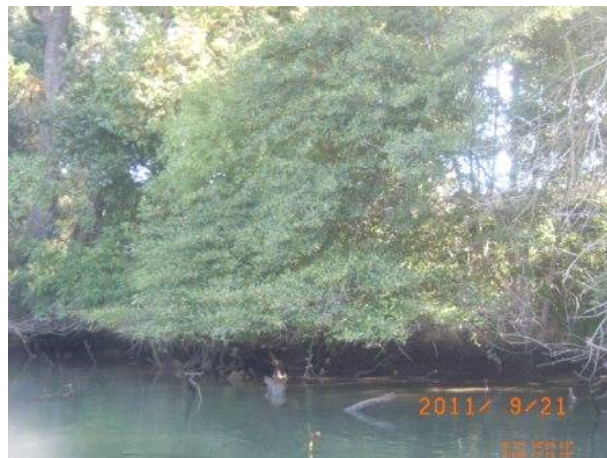
USACE 2011 Photo #3

Levee Mile Report Line	6
Start Levee Mile	0.94
End Levee Mile	1.14
Location	Water Side
Category	Supplemental
Item	USACE Erosion Survey

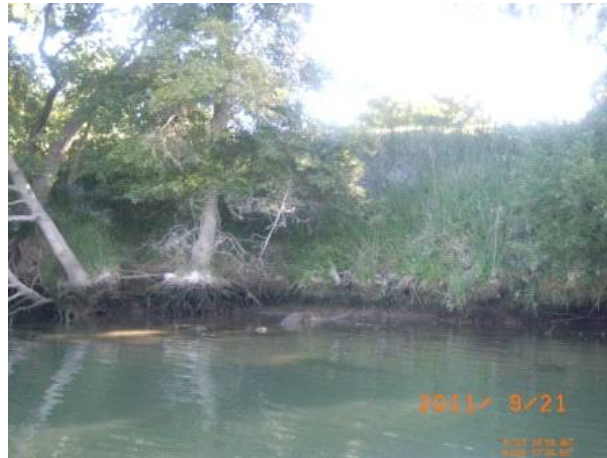
USACE 2011 Photo #4

Levee Mile Report Line	6
Start Levee Mile	0.94
End Levee Mile	1.14
Location	Water Side
Category	Supplemental
Item	USACE Erosion Survey

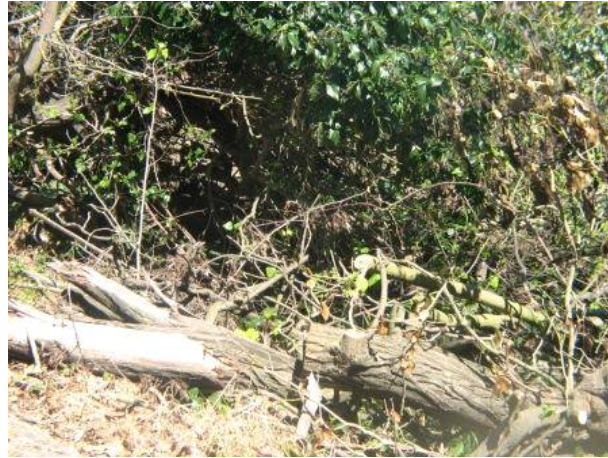
Levee Mile Report Line	9
Start Levee Mile	1.08
End Levee Mile	1.09
Location	Land Side
Category	Earthen Levee
Item	Encroachments

Down tree limbs on landside slope from LM 1.08 to 1.09

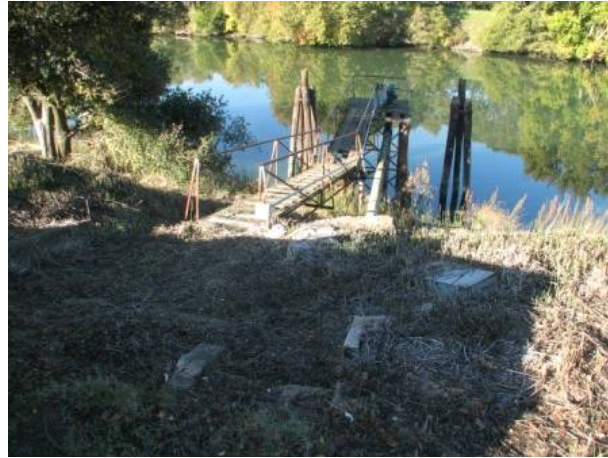
Irrigation pipe penetration.

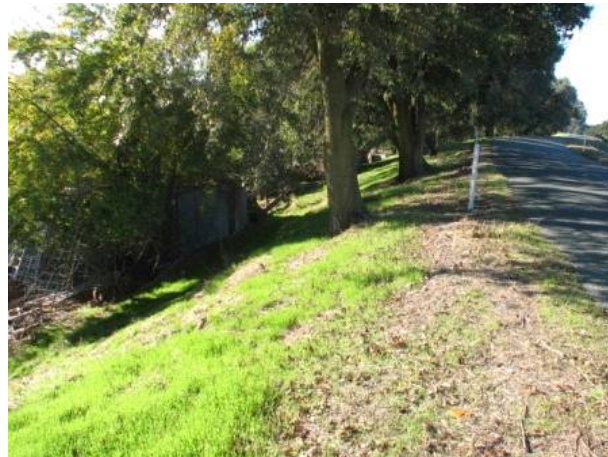
Levee Mile Report Line	13
Start Levee Mile	1.40
End Levee Mile	1.40
Location	Land Side
Category	Earthen Levee
Item	Encroachments

Equipment within 10' of levee toe obstructs access and visibility.

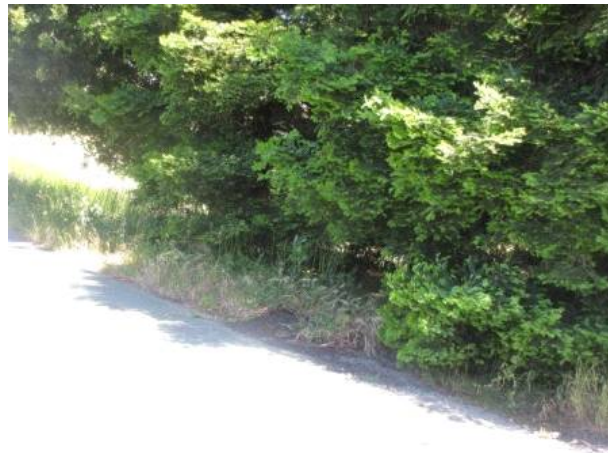
Levee Mile Report Line	14
Start Levee Mile	1.60
End Levee Mile	1.60
Location	Land Side
Category	Earthen Levee
Item	Encroachments

Looking southeast at dense trees on landside shoulder and slope.

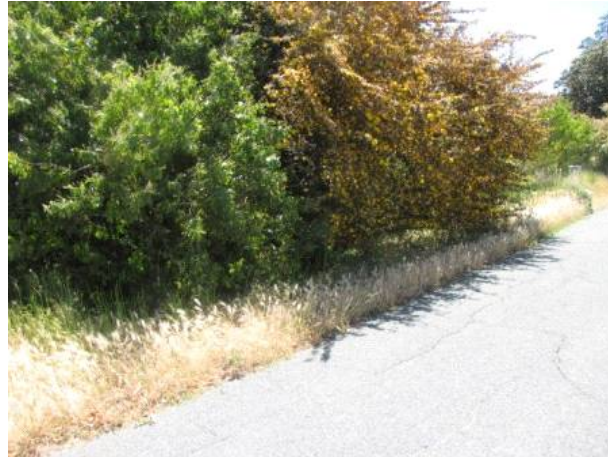
Looking northeast at dense trees on landside slope.

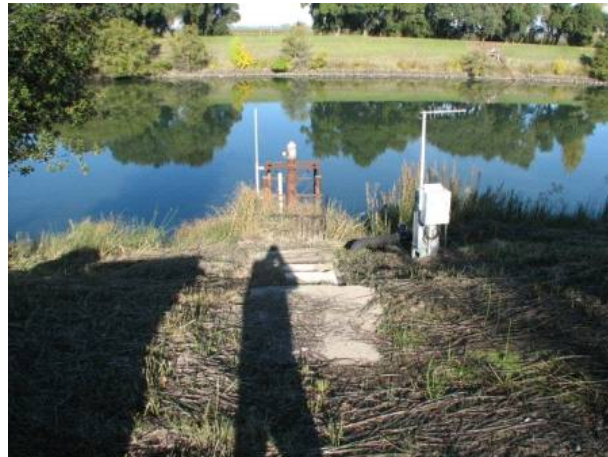
Levee Mile Report Line	16
Start Levee Mile	1.62
End Levee Mile	1.62
Location	Water Side
Category	Earthen Levee
Item	Encroachments

Photo of pipe penetration and USGS equipment.

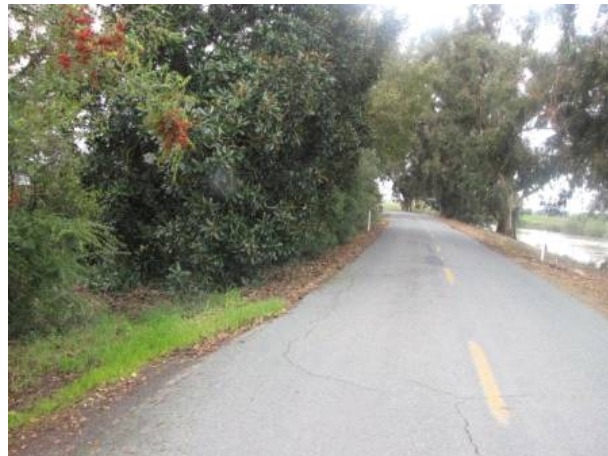
Levee Mile Report Line	17
Start Levee Mile	1.64
End Levee Mile	1.66
Location	Land Side
Category	Earthen Levee
Item	Encroachments

Looking southwest at dense landscaping on landside shoulder and slope.

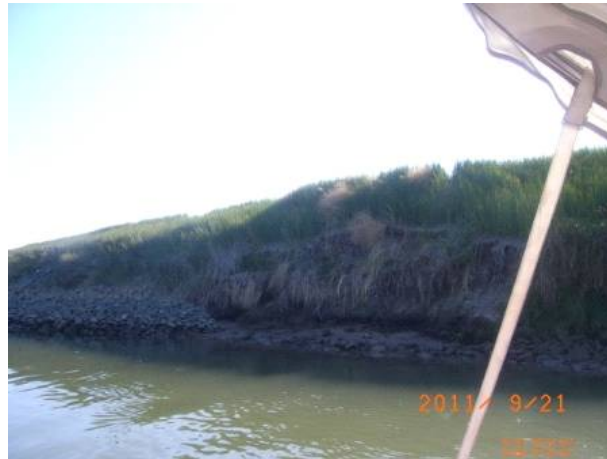
USACE 2011 Photo #2

Levee Mile Report Line	21
Start Levee Mile	2.05
End Levee Mile	2.05
Location	Water Side
Category	Supplemental
Item	USACE Erosion Survey

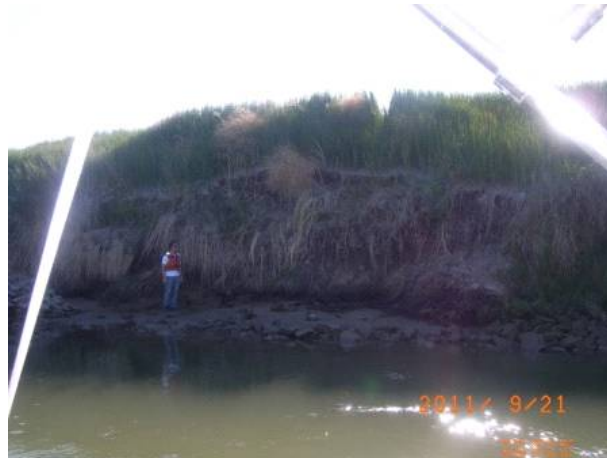
USACE 2011 Photo #3

Levee Mile Report Line	21
Start Levee Mile	2.05
End Levee Mile	2.05
Location	Water Side
Category	Supplemental
Item	USACE Erosion Survey

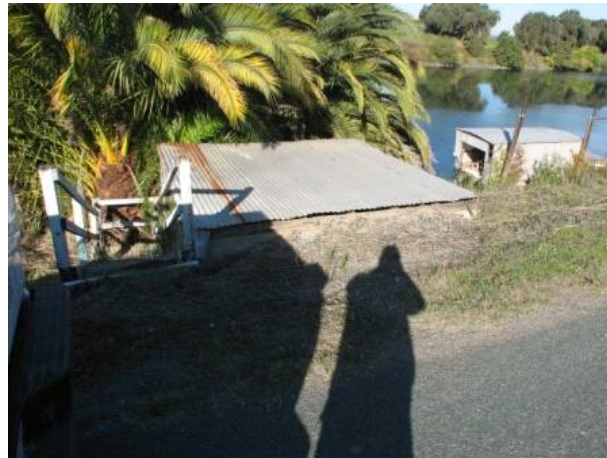
Pipe penetration and pump shed on waterside slope.

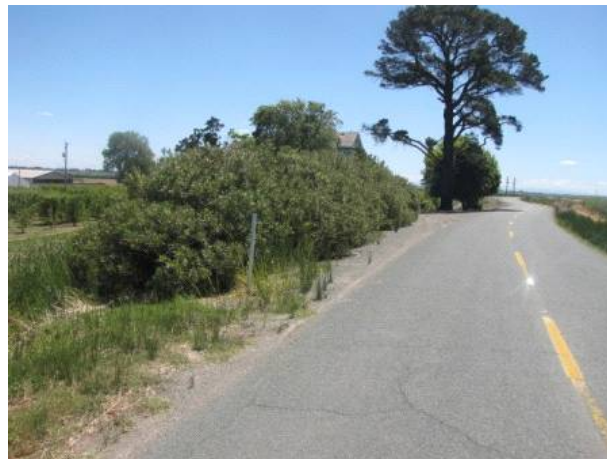
Levee Mile Report Line	30
Start Levee Mile	3.13
End Levee Mile	3.15
Location	Land Side
Category	Earthen Levee
Item	Encroachments

Looking northeast at dense veg. on landside slope.

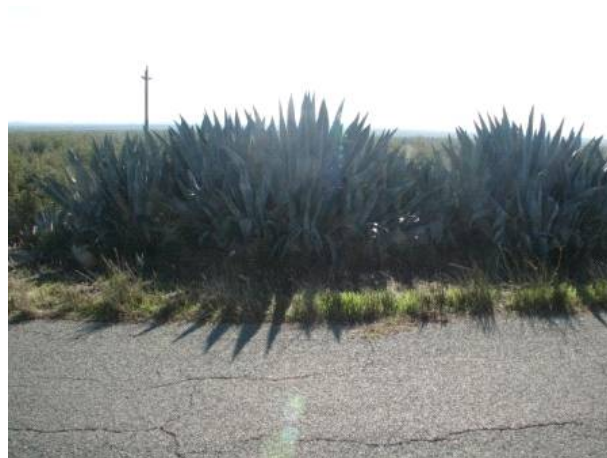
Levee Mile Report Line	34
Start Levee Mile	3.33
End Levee Mile	3.33
Location	Land Side
Category	Earthen Levee
Item	Encroachments

Large cactus on upper levee slope obstructs access and visibility.

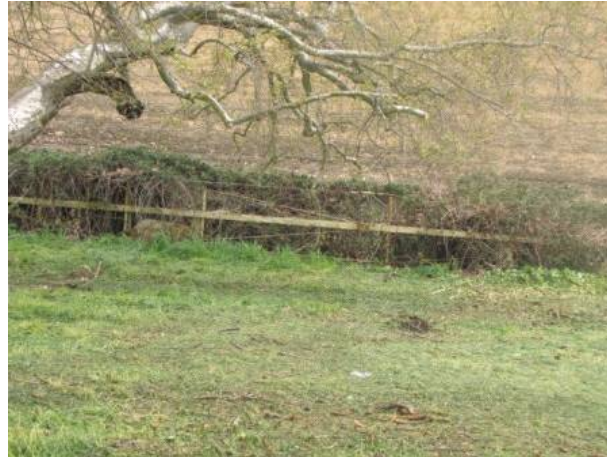
Looking east at dense vegetation covering farm equipment on landside toe.

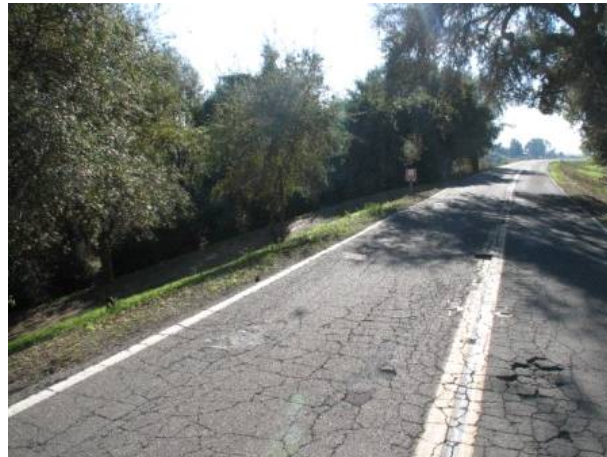
Levee Mile Report Line	51
Start Levee Mile	5.76
End Levee Mile	5.76
Location	Land Side
Category	Earthen Levee
Item	Encroachments

Landscaping on levee slope and within 10' of levee toe obstruct visibility and access.

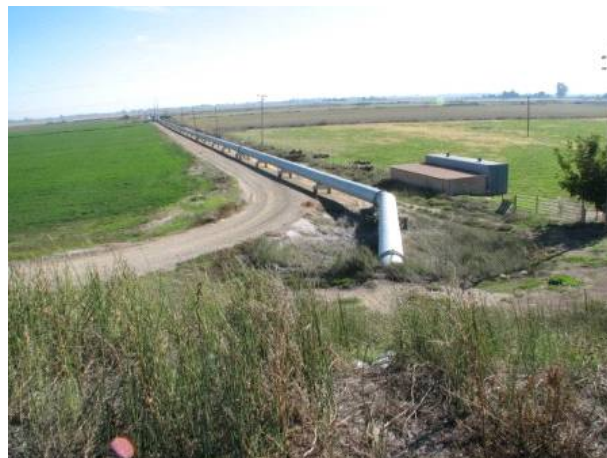
Levee Mile Report Line	55
Start Levee Mile	6.76
End Levee Mile	6.76
Location	Land Side
Category	Earthen Levee
Item	Encroachments

Interior drainage discharge pipe penetrates levee.

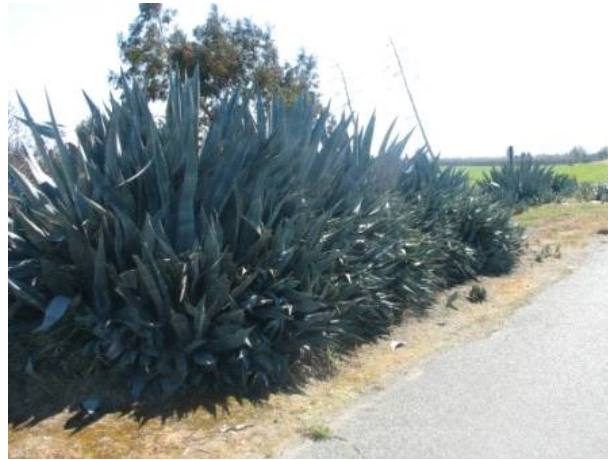
Large Cactus plant on landside shoulder block view of levee slope from LM 7.08 to 7.10

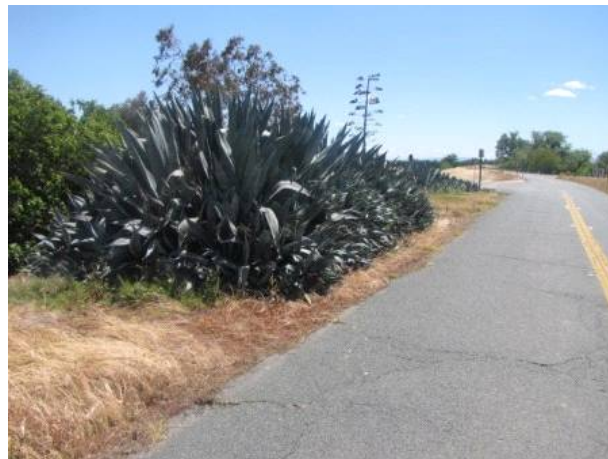
Levee Mile Report Line	58
Start Levee Mile	7.08
End Levee Mile	7.10
Location	Land Side
Category	Earthen Levee
Item	Encroachments

Looking northeast at updated picture (5/2010) century plant on landside shoulder and slope.

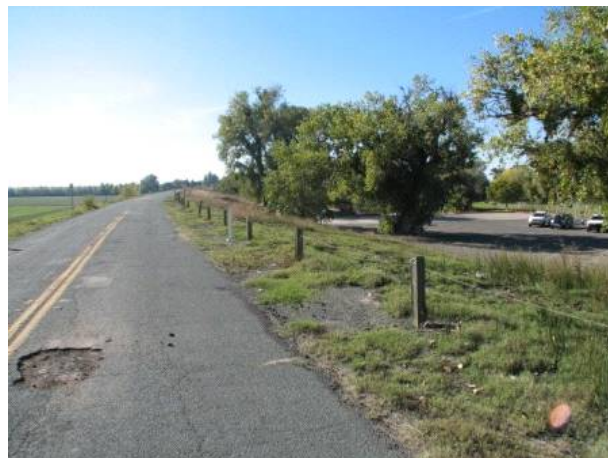
Levee Mile Report Line	59
Start Levee Mile	7.22
End Levee Mile	7.49
Location	Water Side
Category	Earthen Levee
Item	Vegetation

Vegetation on levee slope near boat launch is partially obstructive.

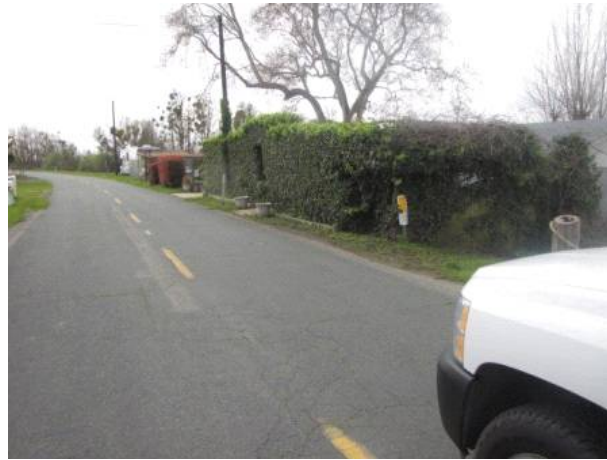
Looking southwest at landscaping in front of a house on waterside berm. Also not in the picture a building on landside berm.

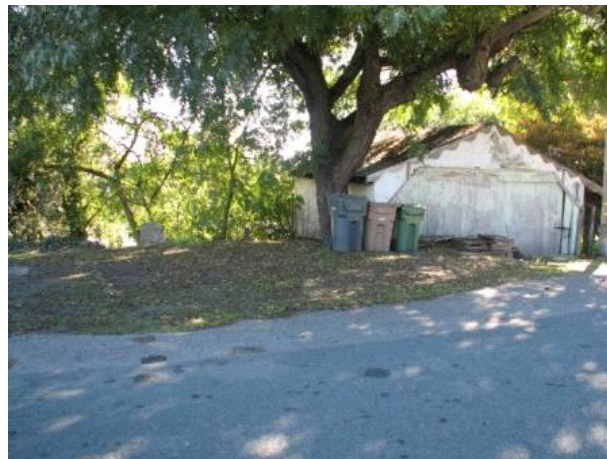
Levee Mile Report Line	62
Start Levee Mile	7.69
End Levee Mile	7.69
Location	Land Side
Category	Earthen Levee
Item	Encroachments

Buildings obstruct access and visibility of levee slope and toe.

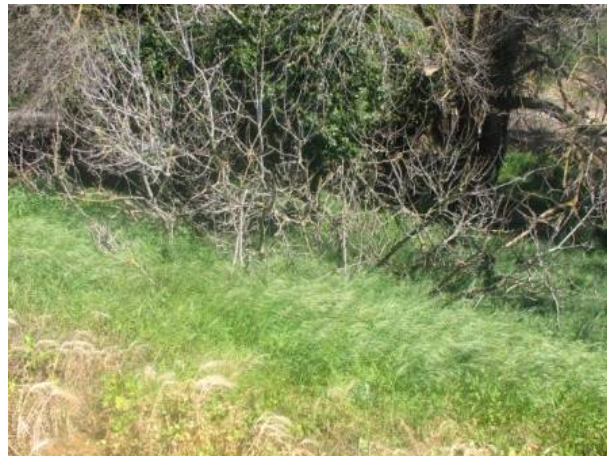
Levee Mile Report Line	64
Start Levee Mile	7.81
End Levee Mile	7.83
Location	Water Side
Category	Earthen Levee
Item	Encroachments

Front view of dense trees at landside toe.

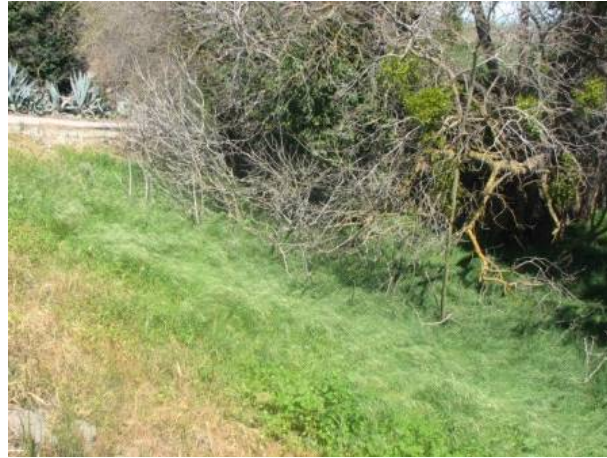
Side view of dense trees at landside toe.

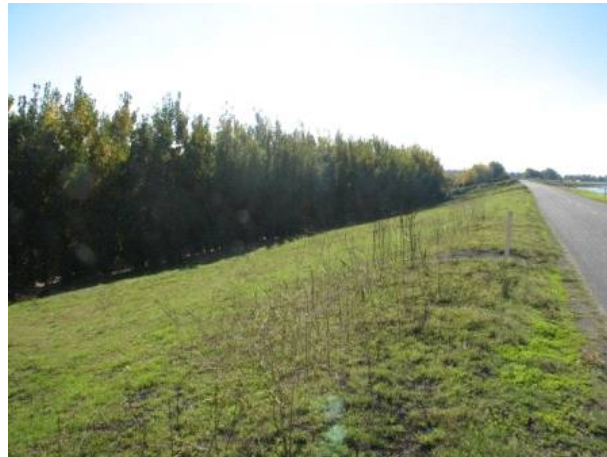
Levee Mile Report Line	65
Start Levee Mile	7.84
End Levee Mile	8.31
Location	Land Side
Category	Earthen Levee
Item	Encroachments

Trees within 10' of levee toe obstruct access and visibility of levee toe.

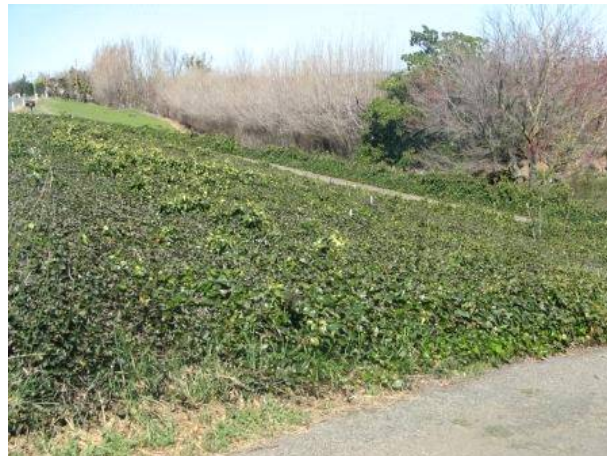
Levee Mile Report Line	67
Start Levee Mile	7.95
End Levee Mile	8.00
Location	Land Side
Category	Earthen Levee
Item	Encroachments

Landscaping (Ivy) on landside slope blocking view of levee from LM 7.95 to 8.00

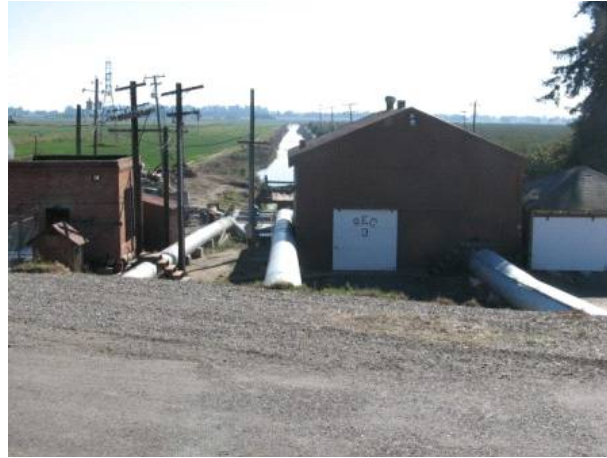
Interior drainage discharge pipes penetrate levee.

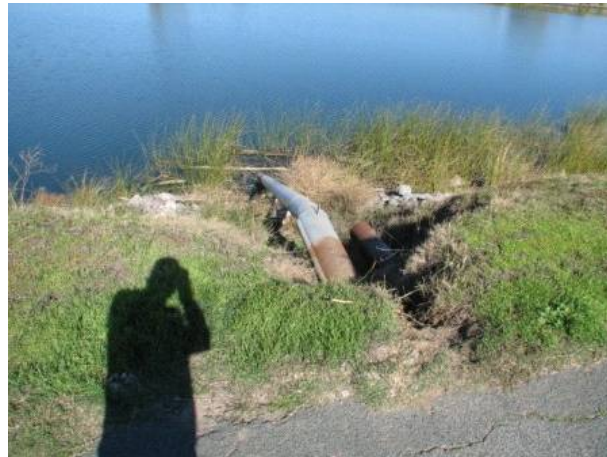
Levee Mile Report Line	79
Start Levee Mile	9.19
End Levee Mile	9.19
Location	Water Side
Category	Earthen Levee
Item	Erosion / Bank Caving

Erosion occurring around pipe penetration.

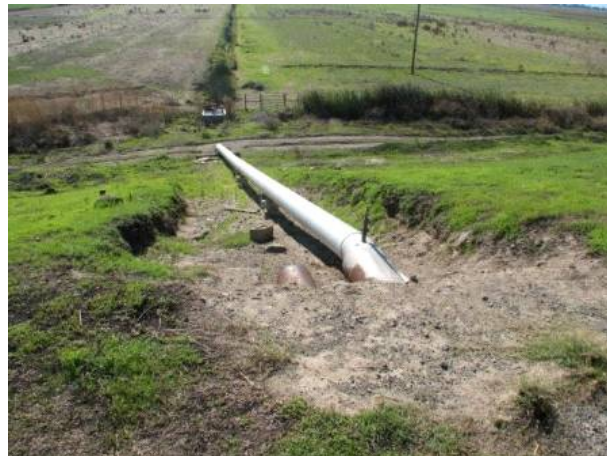
Levee Mile Report Line	80
Start Levee Mile	9.19
End Levee Mile	9.19
Location	Water Side
Category	Earthen Levee
Item	Encroachments

Pipe penetration showing newer pipe next to abandoned pipe.

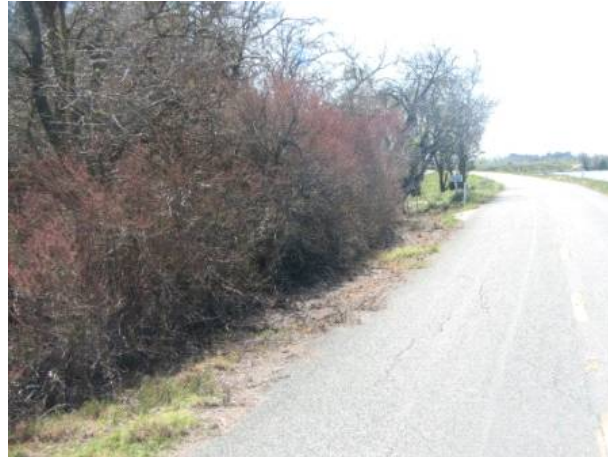
Trees to be trimmed on landside shoulder from LM 10.20 to 10.22

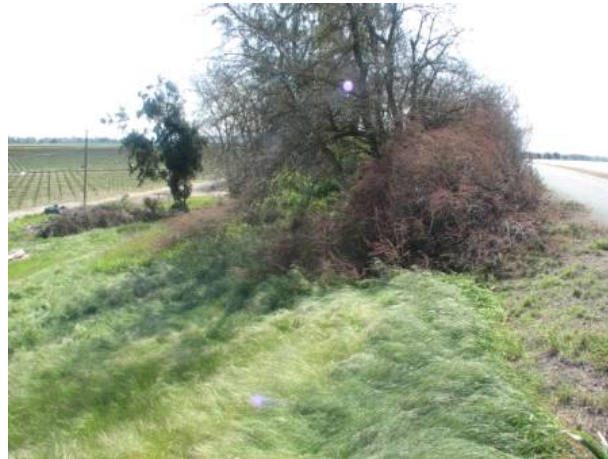
Levee Mile Report Line	82
Start Levee Mile	10.20
End Levee Mile	10.22
Location	Land Side
Category	Earthen Levee
Item	Trim / Thin Trees

Side view of trees on landside shoulder.

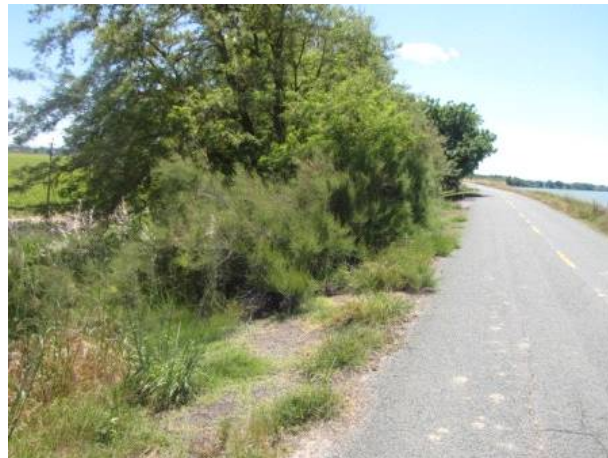
Levee Mile Report Line	82
Start Levee Mile	10.20
End Levee Mile	10.22
Location	Land Side
Category	Earthen Levee
Item	Trim / Thin Trees

Looking north at updated picture (5/10) of dense trees on landside slope.

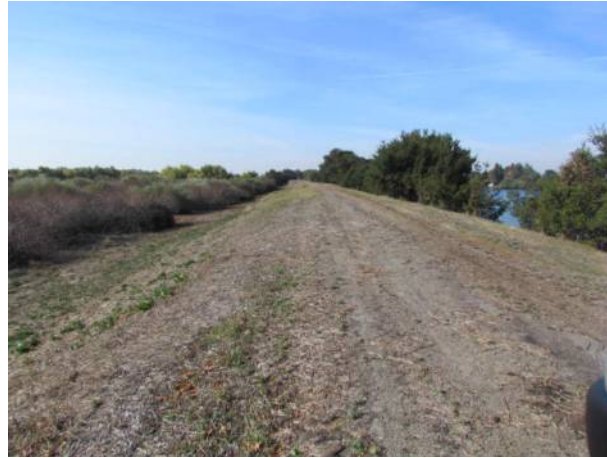
Looking south at typical view of levee between levee mile 10.87 to 11.01

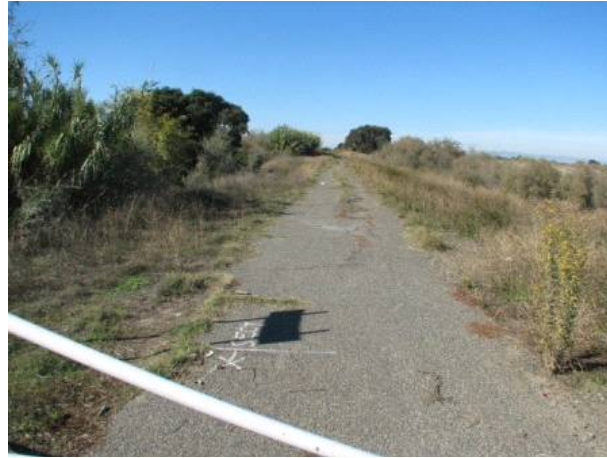
Photo of obstructive vegetation on levee slopes.

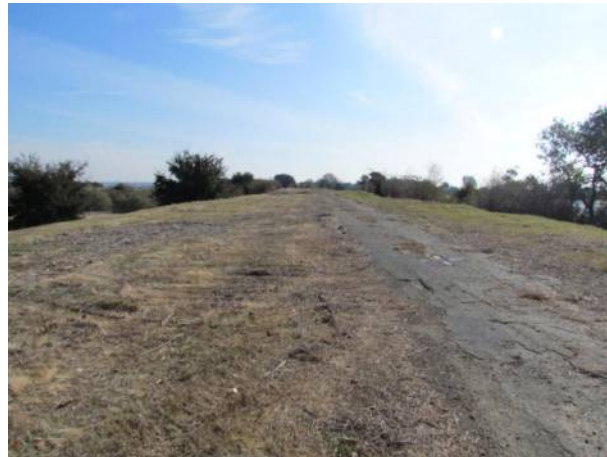
Levee Mile Report Line	1
Start Levee Mile	0.00
End Levee Mile	0.40
Location	Land Side
Category	Earthen Levee
Item	Vegetation

Looking northeast a typical view of levee between levee mile 0.00 to 0.44

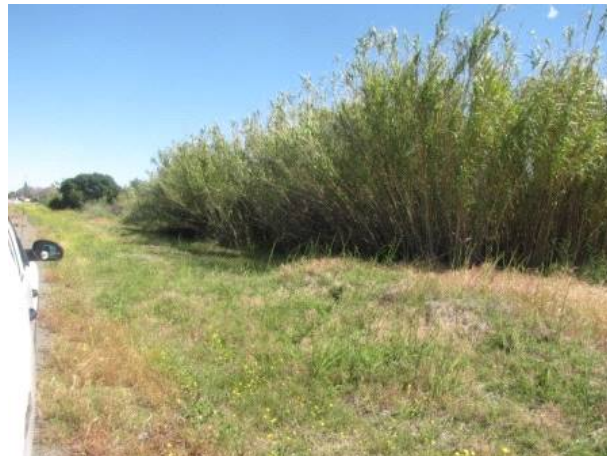
richard_f_20111014_995.jpg

Looking northeast at bamboo on waterside slope.

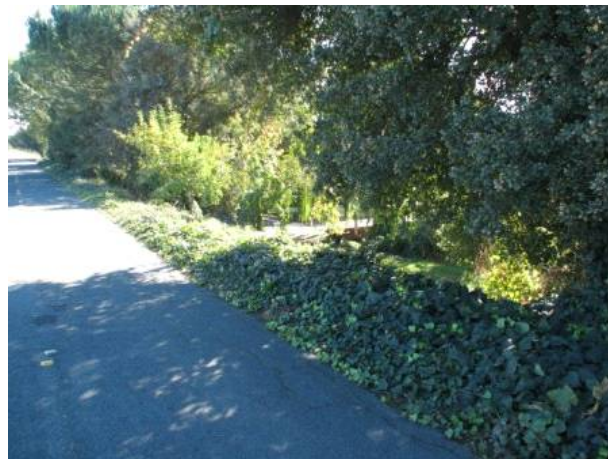
Levee Mile Report Line	8
Start Levee Mile	1.93
End Levee Mile	1.98
Location	Water Side
Category	Earthen Levee
Item	Encroachments

Landscaping on levee slope obstructs visibility and access.

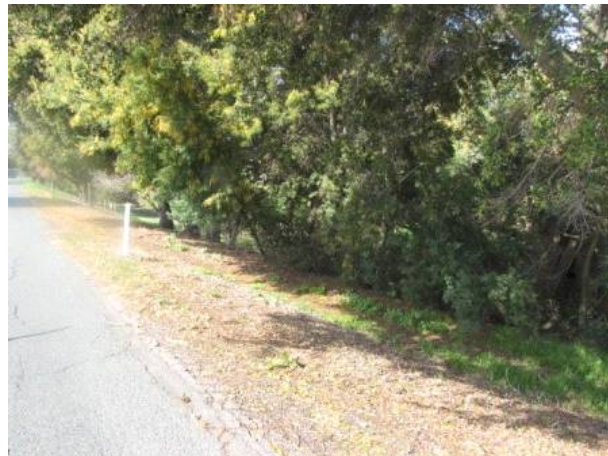
Levee Mile Report Line	13
Start Levee Mile	3.29
End Levee Mile	3.29
Location	Land Side
Category	Earthen Levee
Item	Trim / Thin Trees

Looking west at dense vegetation on landside slope and toe.

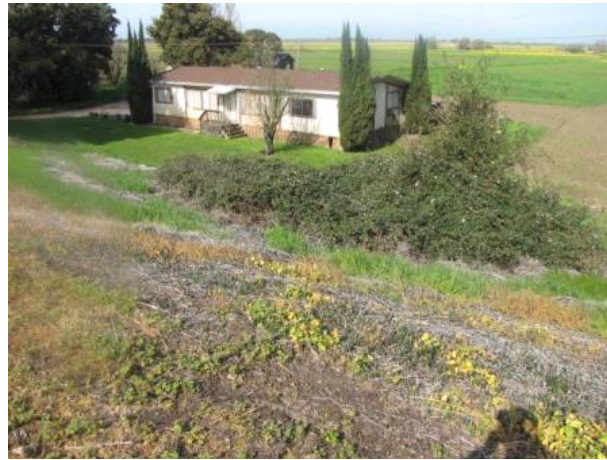
Levee Mile Report Line	14
Start Levee Mile	3.32
End Levee Mile	3.32
Location	Land Side
Category	Earthen Levee
Item	Vegetation

Looking west at berryvines on landside toe.

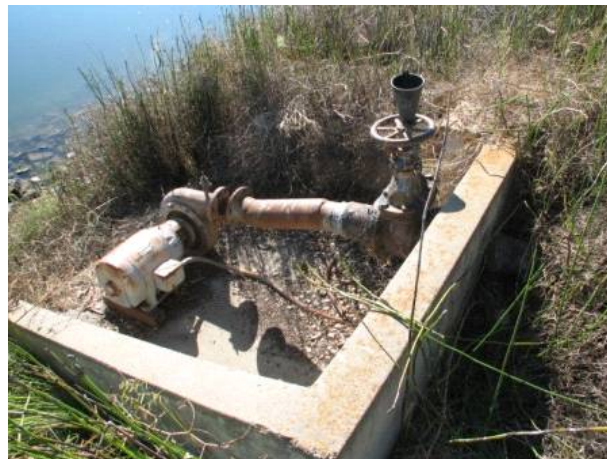
Levee Mile Report Line	15
Start Levee Mile	3.39
End Levee Mile	3.39
Location	Water Side
Category	Earthen Levee
Item	Encroachments

Pipe penetration closure valve in open position.

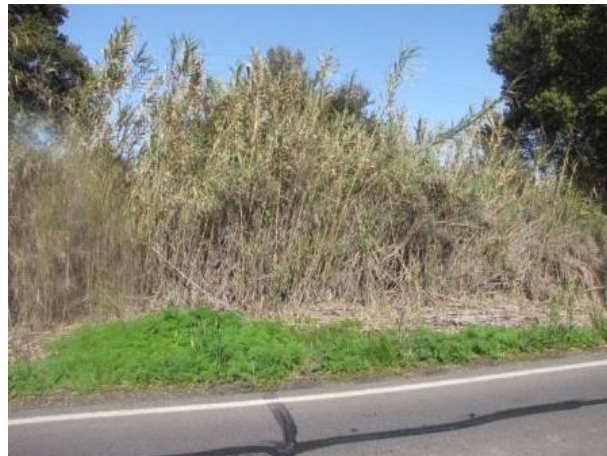
Levee Mile Report Line	18
Start Levee Mile	3.87
End Levee Mile	3.87
Location	Land Side
Category	Earthen Levee
Item	Vegetation

Looking west at dense bamboo on landside slope.

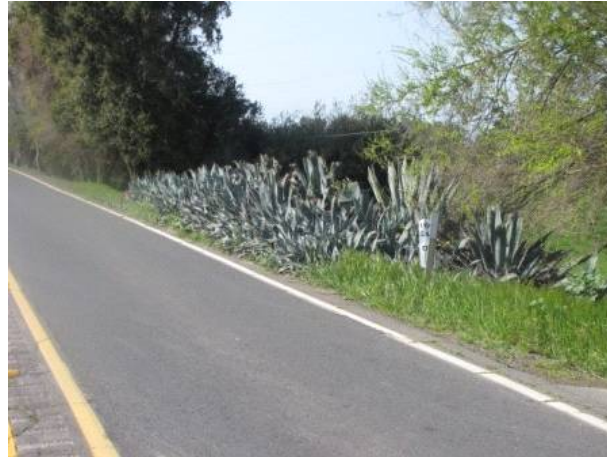
Levee Mile Report Line	21
Start Levee Mile	4.22
End Levee Mile	4.22
Location	Land Side
Category	Earthen Levee
Item	Encroachments

Looking west at cactus on landside slope.

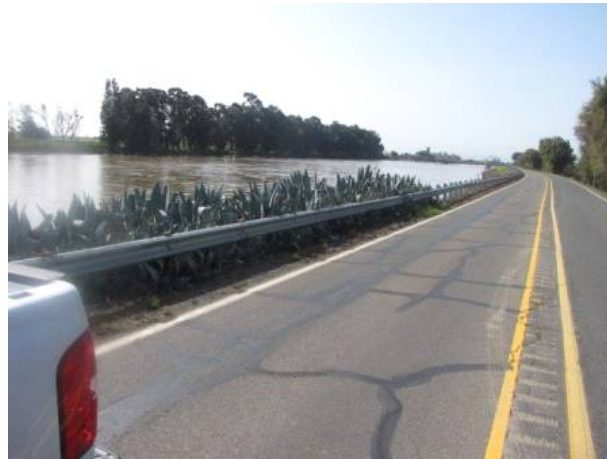
Levee Mile Report Line	21
Start Levee Mile	4.22
End Levee Mile	4.22
Location	Land Side
Category	Earthen Levee
Item	Encroachments

Looking southeast a cactus on waterside shoulder and slope.

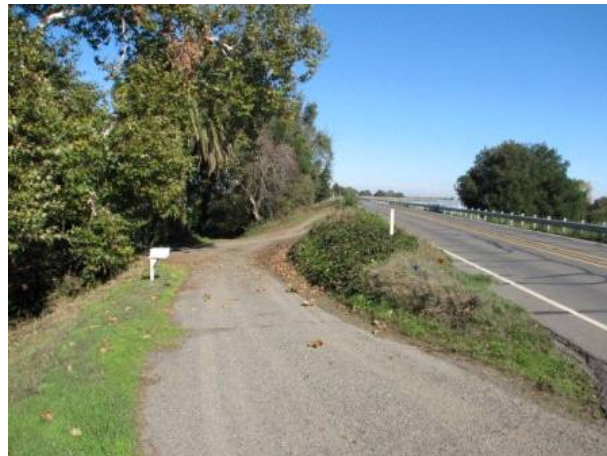
Levee Mile Report Line	24
Start Levee Mile	4.36
End Levee Mile	4.42
Location	Land Side
Category	Earthen Levee
Item	Encroachments

Landscaping on levee slope and toe obstructs access and visibility.

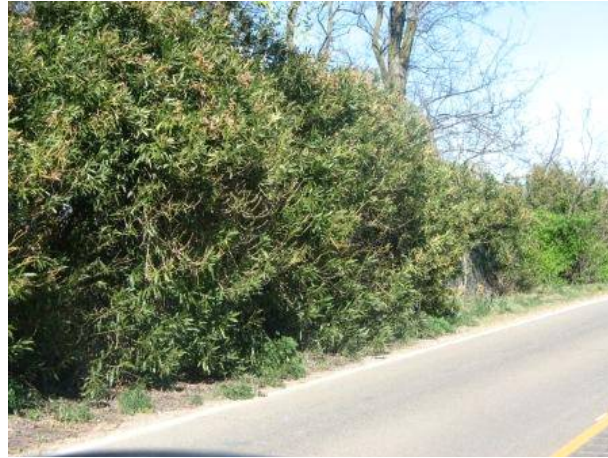
richard_f_20111014_997.jpg

Oleander on landside shoulder blocking view of levee slope from LM 5.94 to 6.00

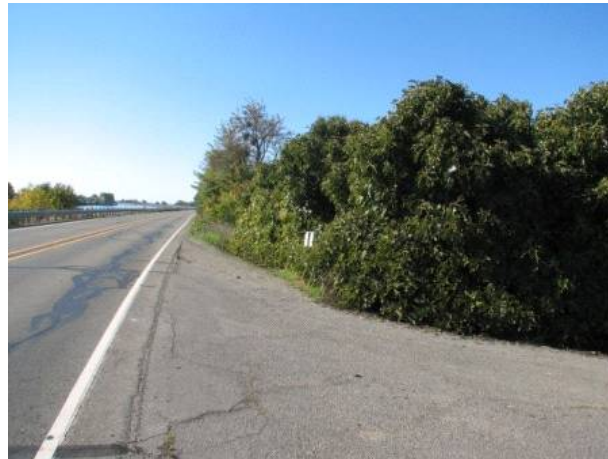
Levee Mile Report Line	31
Start Levee Mile	5.94
End Levee Mile	6.00
Location	Land Side
Category	Earthen Levee
Item	Encroachments

Landscaping on levee slope and toe obstructs access and visibility.

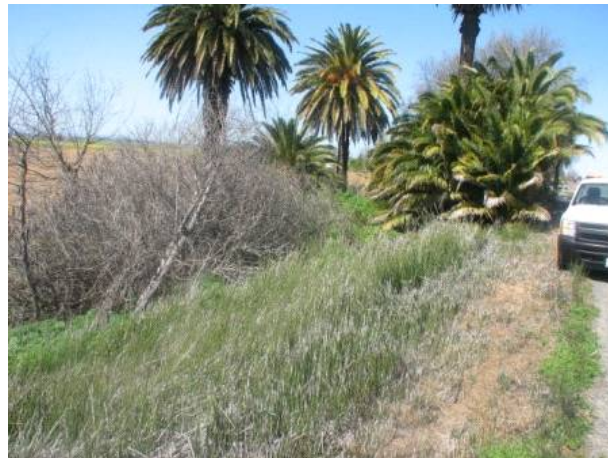
Levee Mile Report Line	34
Start Levee Mile	7.02
End Levee Mile	7.04
Location	Land Side
Category	Earthen Levee
Item	Trim / Thin Trees

Dense trees at landside toe and shoulder

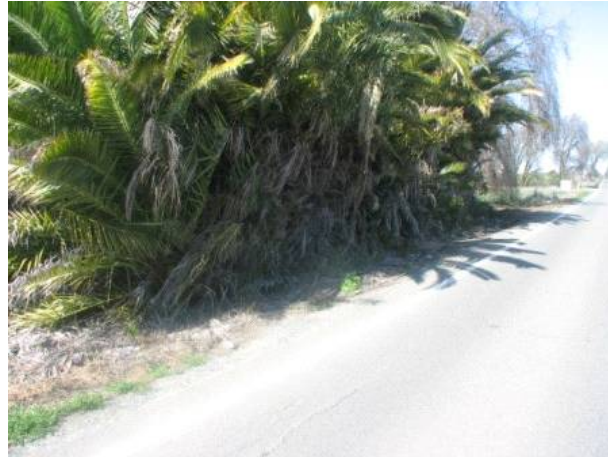
richard_f_20111014_000.jpg

Front view of palm trees on landside shoulder

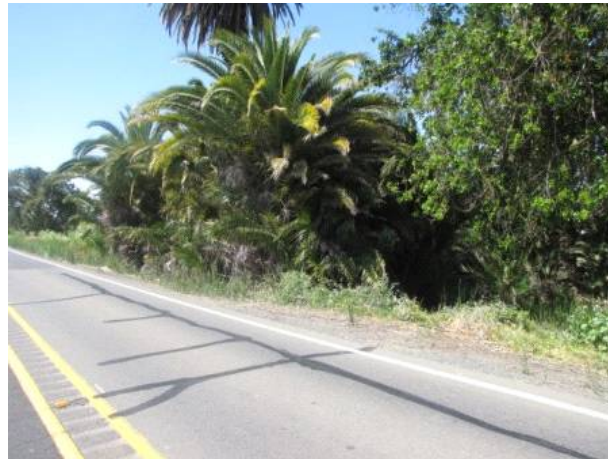
Levee Mile Report Line	34
Start Levee Mile	7.02
End Levee Mile	7.04
Location	Land Side
Category	Earthen Levee
Item	Trim / Thin Trees

Looking southwest at updated dense veg on landside slope.

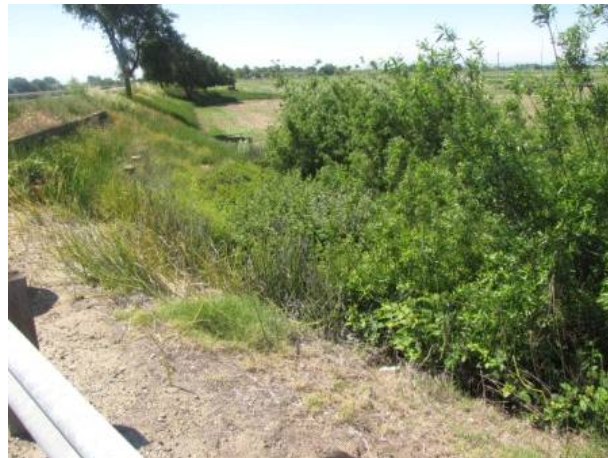
Levee Mile Report Line	35
Start Levee Mile	7.16
End Levee Mile	7.16
Location	Land Side
Category	Earthen Levee
Item	Vegetation

Looking southwest at dense veg. on landside toe.

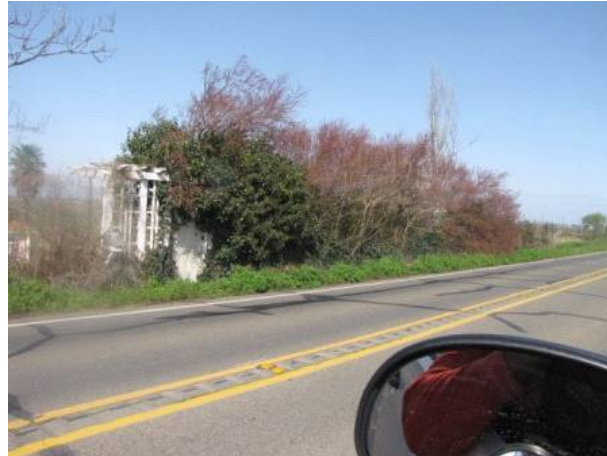
richard_f_20111014_009.jpg

Looking northwest a dense landscaping on landside shoulder and slope.

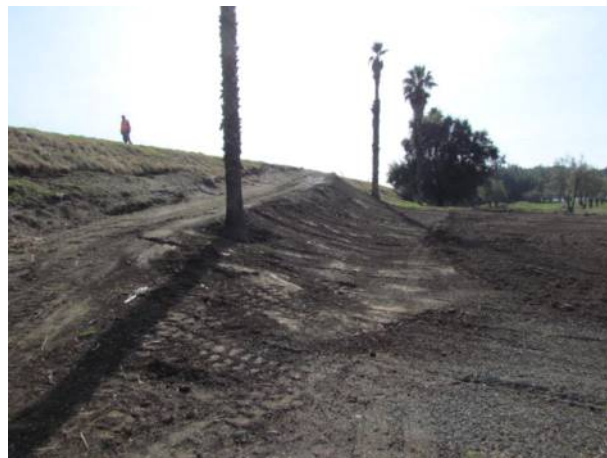
Levee Mile Report Line	43
Start Levee Mile	9.19
End Levee Mile	9.19
Location	Land Side
Category	Earthen Levee
Item	Encroachments

Looking south at unauthorized ramp on landside slope.

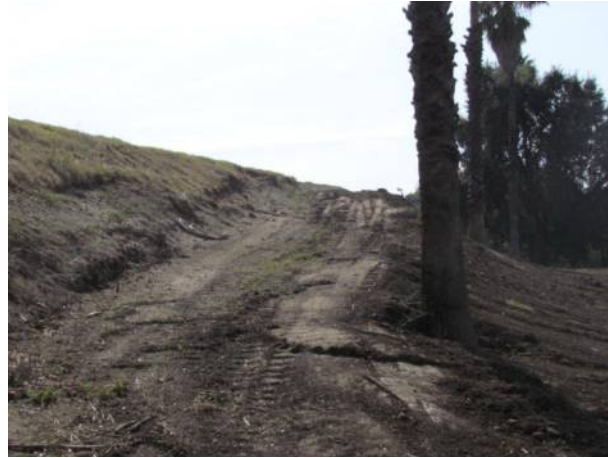
richard_f_20111116_454.jpg

Looking southeast at ramp on landside slope.

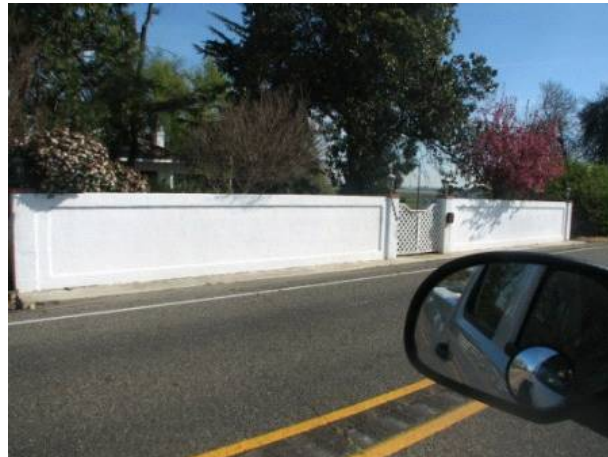
Levee Mile Report Line	50
Start Levee Mile	10.13
End Levee Mile	10.13
Location	Land Side
Category	Earthen Levee
Item	Encroachments

Block/Concrete fence on landside shoulder at LM 10.13

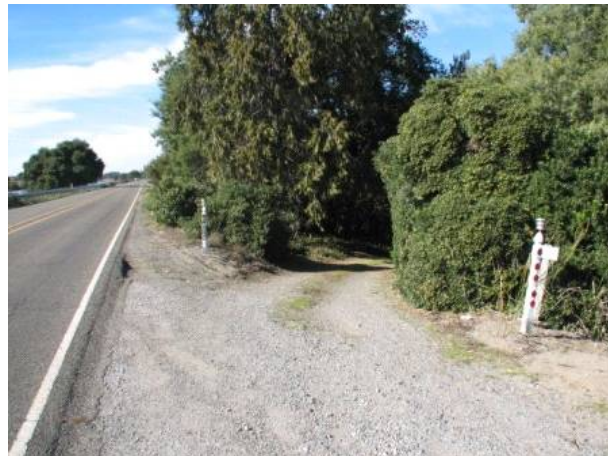
Levee Mile Report Line	53
Start Levee Mile	10.74
End Levee Mile	10.74
Location	Land Side
Category	Earthen Levee
Item	Encroachments

Landscaping on levee slope and toe obstructs access and visibility.

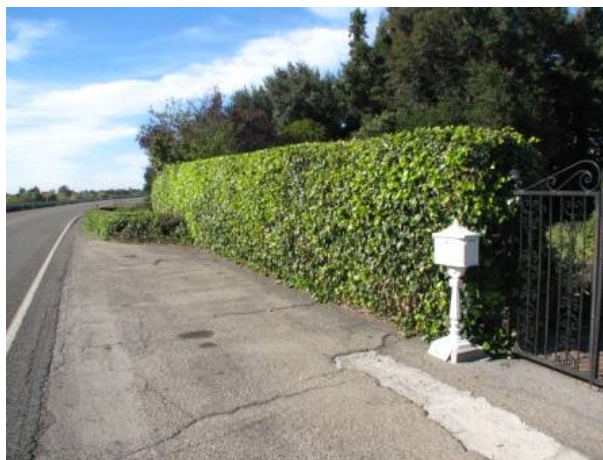
richard_f_20111014_012.jpg

Landscaping on levee slope obstructs access and visibility.

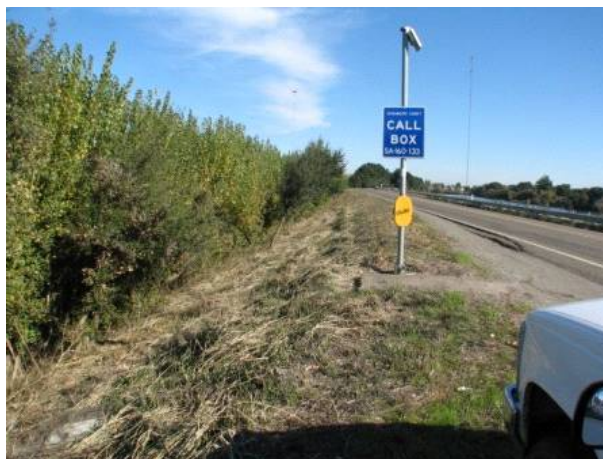
Levee Mile Report Line	56
Start Levee Mile	11.12
End Levee Mile	11.35
Location	Land Side
Category	Earthen Levee
Item	Encroachments

Landscaping trees on levee slope an toe obstruct access and visibility.

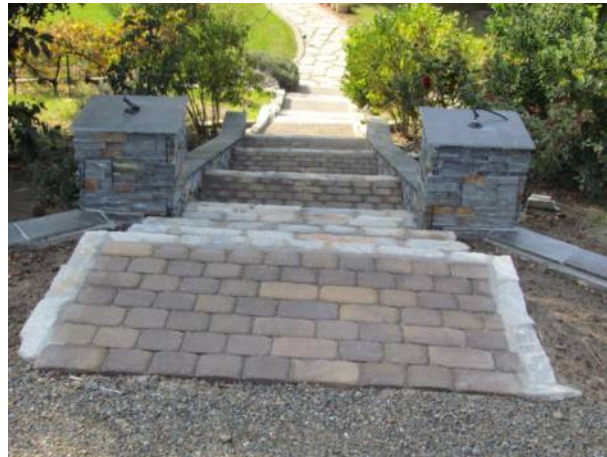
Levee Mile Report Line	69
Start Levee Mile	13.60
End Levee Mile	13.60
Location	Land Side
Category	Earthen Levee
Item	Encroachments

Looking west at stairs on landside slope.

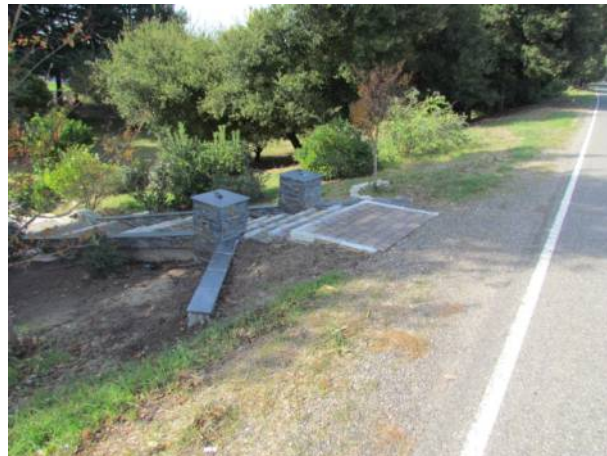
Levee Mile Report Line	69
Start Levee Mile	13.60
End Levee Mile	13.60
Location	Land Side
Category	Earthen Levee
Item	Encroachments

Looking northwest at stairs on landside slope.
